2001 Sea Ray 270 Sundancer

"Infinity"

Report of Marine Survey

Conducted by
Eric Dickerson, SAMS®, SA®

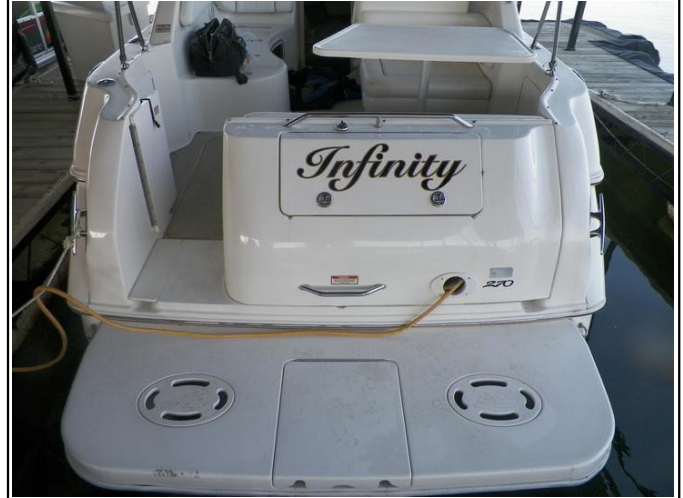
Transom/swim platform/cockpit

- * TRANSON: [C2] FRP forward curved style transom with white gelcoat and non-skid in key areas and lettering (name of vessel). The transom is fitted with a transom door, an accessory storage locker (needs to be cleaned on the inside and pneumatic cylinder will not hold locker in open position), shore power cord inlet, stainless steel grab rails, stern light port connector, and two (2) stern eyes. A swim platform is mounted to the transom with a swim ladder/reboarding ladder that is deployable by person in the water. Below the swim platform, the transom is fitted with an outdrive, trim tabs, and drain fitting. Transom area is in good condition and all items serviceable and well secured. Moisture meter and percussion sounding revealed unremarkable results. The swim platform has two (2) noticeable chipped and gouged areas to the gelcoat along the edge and rub rail is marked from rubbing. The owner states he will repair the noted gelcoat areas on the edge of swim platform.

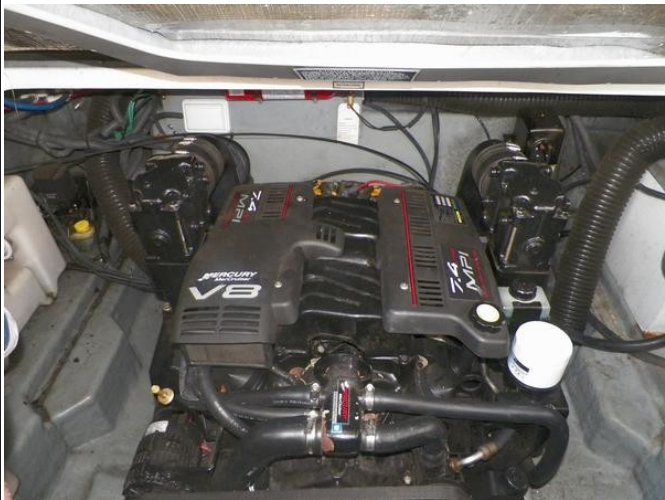
- * BILGE: [C3] Engine space bilge is a gray gelcoat and it is dirty with oil residue and has an estimated one (1) inch of water. The engine space gelcoat appears to be in good condition where sighted.

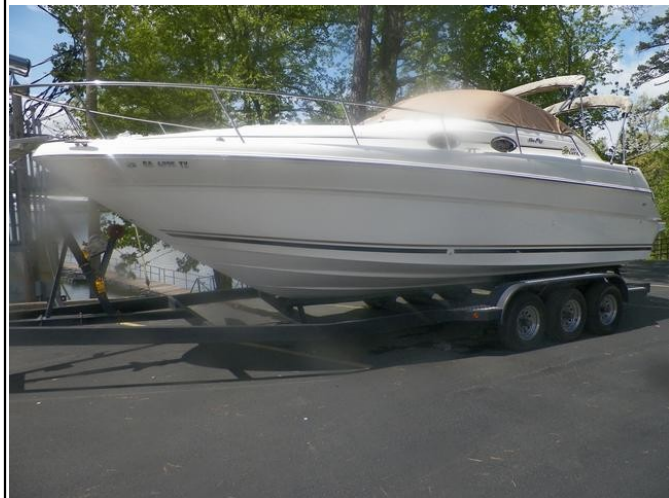
Port view vessel on trailer

- * EXTERIOR HULL: [C1] Topsides are a white gelcoat, Sea Ray refers to the gelcoat as arctic white, with gold and black boot stripes. The port topsides has two (2) gouges, approximately three (3) inches each, on the amidships area. Owner states that he will repair these two (2) gouges. The black boot stripe is worn along a majority of the bottom edge throughout and two (2) spots, on the port side, are worn the for most of the thickness of the stripe. The gelcoat on the port side sheer line, located in the area below port lights, is dull for an estimated area of two (2) feet. Owner states that this was due to the removal of a decal and not a repair. Overall the gelcoat finish is good condition. White polymer rubrail with stainless steel insert encompasses the sheer line. The rubrail has minor scratches on the stainless steel insert and one minor area of surface rust sighted, overall in good condition and well secured.
